Hot zone contamination

This sixth article in our series on vacuum heat treating examines contamination of the normally high-purity vacuum environment and explains how to determine if the hot zone is at fault.

by WILLIAM R. JONES

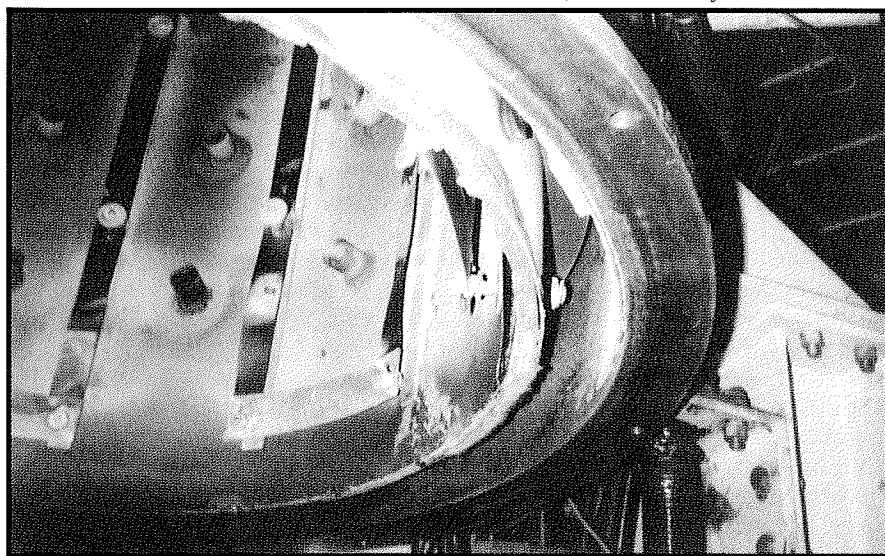
and debris was collected. This was made up of dehydrated oils, grease, binders, and an assortment of products of bake-out from hundreds of workloads. This 50-inch furnace was in a commercial heat treat shop and was exposed to numerous applications. It was observed that improper product degreasing was a factor, and a new and larger vapor degreaser was installed to help clean up products entering the furnace. One of the products run in this furnace was coils of tubing difficult to clean on the I.D. After clean-up and restart of the vacuum furnace, and a few "run in" cycles, the furnace was restored to fully satisfactory, clean operation as was the previous experience.

"White" contamination appears around the cold wall of a vacuum chamber and the outside of a hot zone assembly in a bottom-loading vacuum furnace.

The furnace hot zone was pulled out of the furnace for inspection, and it was noted that the entire outer hot zone assembly was coated with between 1/8- and 3/16-inch of dirt. The same was true for the entire inner cold wall for the vacuum chamber. This was thoroughly scraped out of the furnace internals and cold wall area, and then washed down with solvent, mineral spirits, followed by acetone. One full cubic foot of dirt

similar experiences with various vacuum furnace manufacturers. For some applications and installations, it may be necessary to schedule a hot zone tear-out and furnace scrape and clean-up on a regular, once-every-two-year basis.
